FHWA/CA/TL-83/05

Vehicle Impact Tests of A See-Through,
Collapsing Ring, Structural Steel Tube, Bridge Barrier Railing

June 1983

VEHICLE IMPACT TESTS OF A
SEE-THROUGH, COLLAPSING RING,
STRUCTURAL STEEL TUBE,
BRIDGE BARRIER RAILING

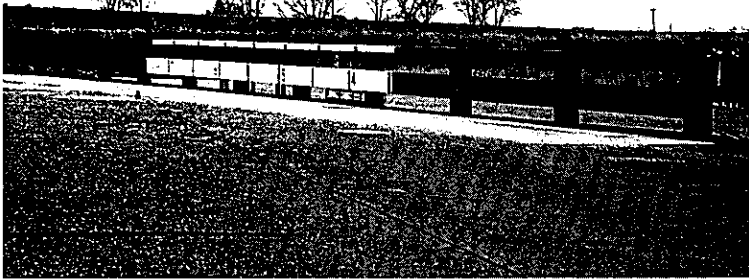
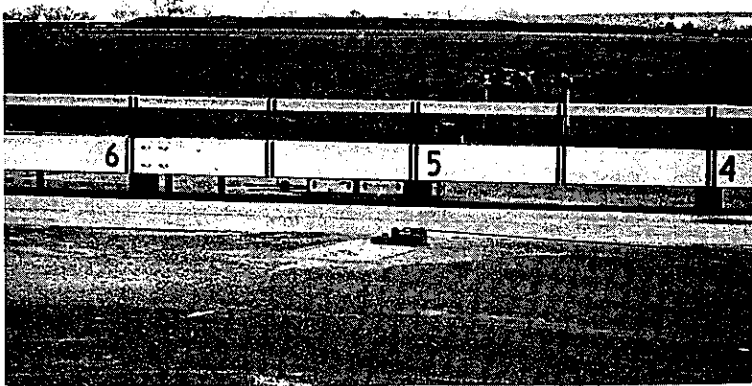
FIGURE 4
TEST BARRIER

W8x31 Posts
@ 8'-0"

4"x4"x1/4" Top Rail
Top of Rail Height = 36"

3"x12"x1/4" Bottom Rail
Top of Rail Height = 22"

The bridge rail was designed by the Transportation Laboratory and the Office of Structures Design. Figures 4, 5 and 6 show several views of the test barrier. The test barrier plans are contained on Figures E1 and E2 in Appendix E. Following is a list of the key components of the bridge rail and the material specifications:

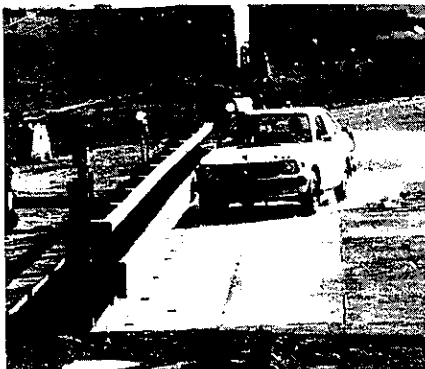
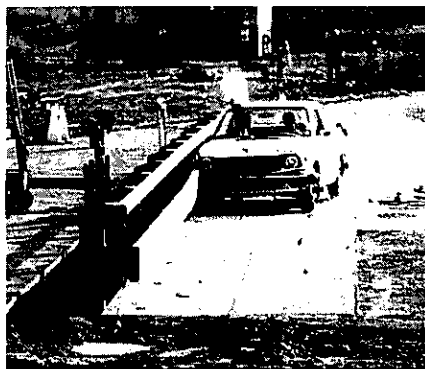
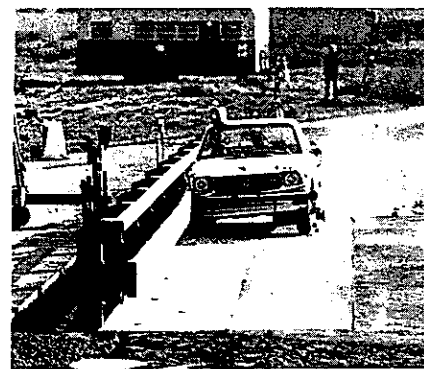
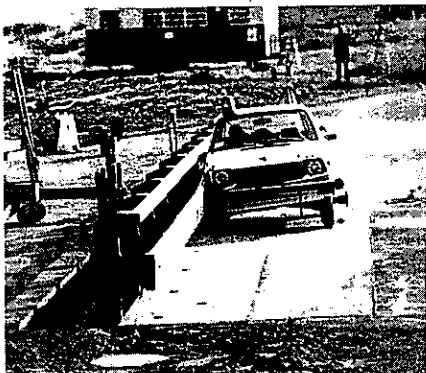
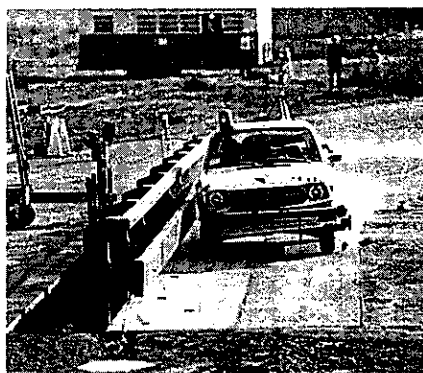
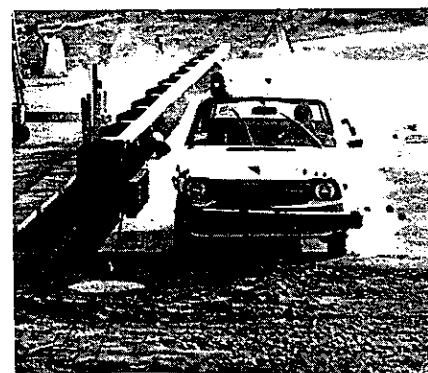
FIGURE 7 DATA SUMMARY SHEET - TEST 411

Impact + 0.022 Sec

I + 0.078 Sec

I + 0.133 Sec

I + 0.189 Sec

I + 0.301 Sec

I + 0.635 Sec

The Data Summary Sheet and photos taken before and after impact are shown in Figures 7 through 12. A film report showing Tests 411 and 412 is available for viewing.

The car pulled to the right on the guidance cable as it approached the barrier. The rear half of the car pulled farther to the right than the front half which was restrained by the wheel bracket. The wheel bracket on the left front wheel of the car actually slipped off the guidance cable a few feet in front of the cable anchorage. Consequently, there was a slight reduction in the angle of impact which was about 12° instead of the intended 15°. The car contacted the barrier between posts 5 and 6, about 1.6 feet downstream from post 5 instead of at midspan as intended. The length of vehicle contact with the barrier

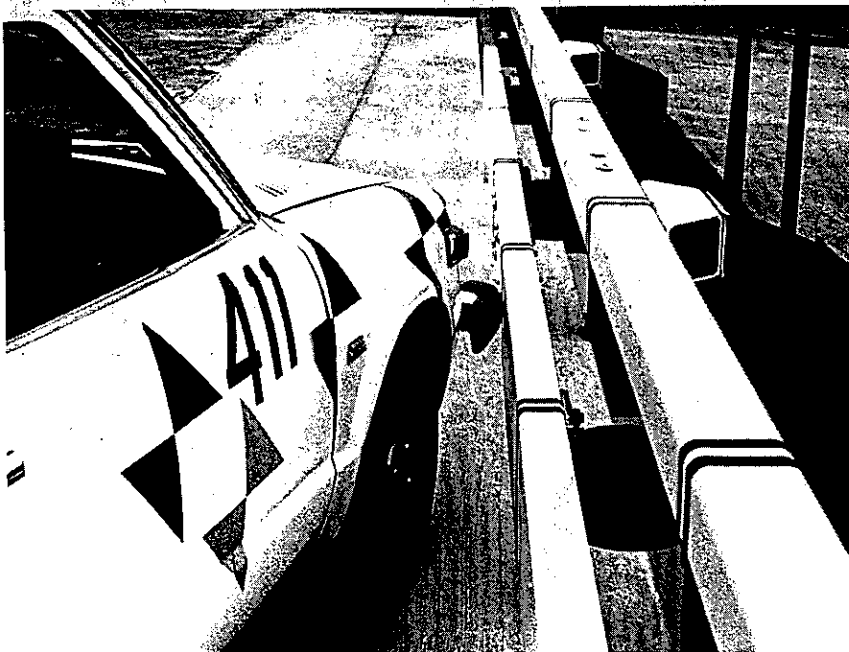
FIGURE 10 TEST 411 CRUSHED PIPE RINGS

Top View - Car at 15° Angle
With Test Barrier Contacting
3"x12" Tube

Car at 15° Angle With
Test Barrier

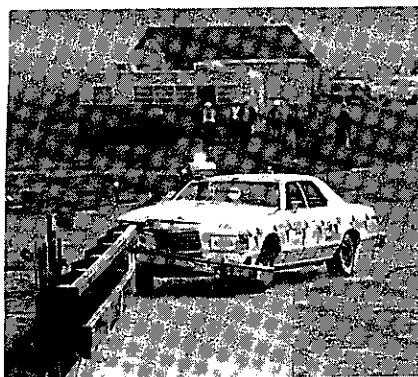
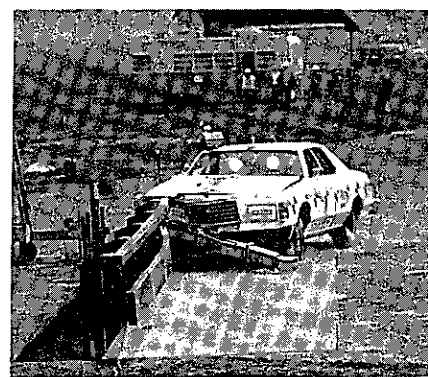
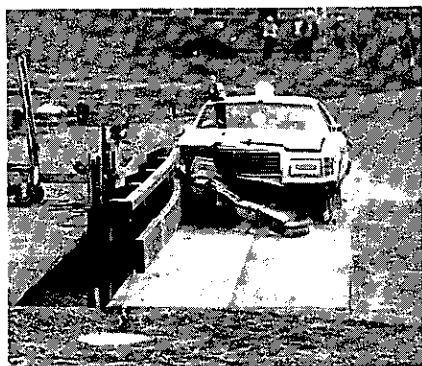
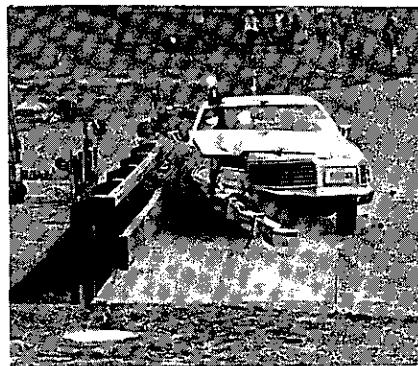
Impact + 0.005 Sec

I + 0.061 Sec

I + 0.116 Sec

I + 0.172 Sec

I + 0.282 Sec

The key objective of this test was to check the structural adequacy of the bridge rail; therefore, the vehicle was remotely braked immediately after it lost contact with the rail. The wheels locked up a few feet before the end of the concrete deck. The vehicle continued to turn to the left after it left the pavement and continued across a soft earth field. The braking, turning and soft earth eventually caused the vehicle to turn close to 90° away from the line of the bridge rail, and to roll slowly over (180°) on its top. It came to rest at the toe of the earth berm 90 feet beyond the end of the test barrier. During impact, the maximum 50 millisecond average value of lateral vehicle acceleration was -9.5 g's and the comparable value of longitudinal vehicle acceleration was -5.1 g's. The occupant impact velocity was 23.5 fps in the lateral direction and 16.7 fps in the longitudinal direction.

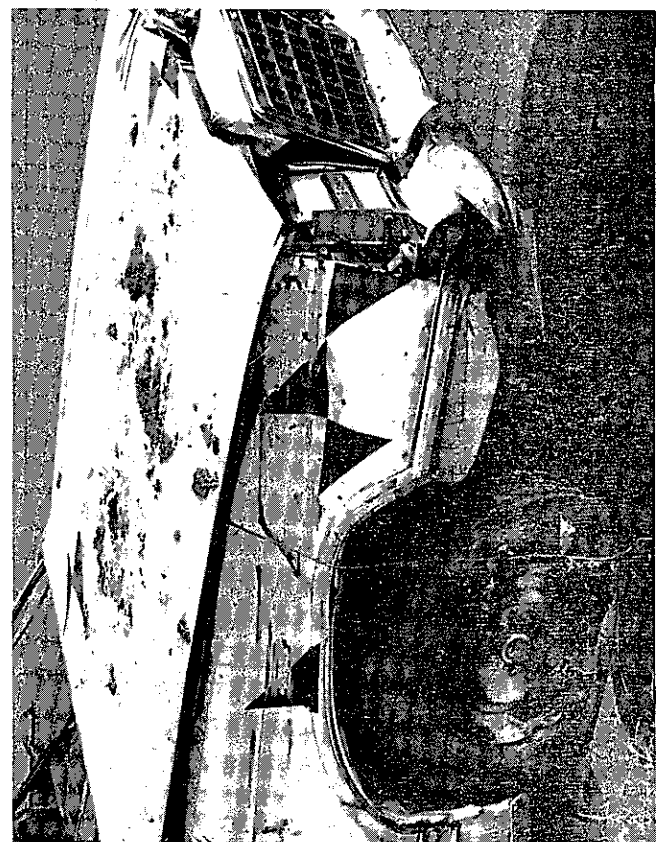
FIGURE 20 TEST 412 VEHICLE DAMAGE

Final Location of Driver
Dummy After Impact.

Front End of Vehicle. End
of Frame is Bent to the Left
Where Bumper was Sheared
Off.

Roof Damage Due to Rollover Was Increased
Due to Sliding Weight Device on Roof

Minor Damage at Right Rear Corner of Vehicle

Impact Side of Vehicle

Crush at Top of Fender is From 4"x4" Tube Rail

The right front tire went flat after the test. When that wheel contacted the button head bolts on the 3x12 rail splice, the rim was crinkled and cupped at several points. Severe scraping of the right front wheel showed much of the force of the impact was taken at this point. Front end damage was a little too severe for the vehicle to be driven after the test.
